**National Highway
Traffic Safety
Administration**

DYNAMIC SCIENCE, INC.
In-Depth Accident Investigation

Contract DTNH22-87C-47169
Case DSI-93-AB-013

TECHNICAL SUMMARY

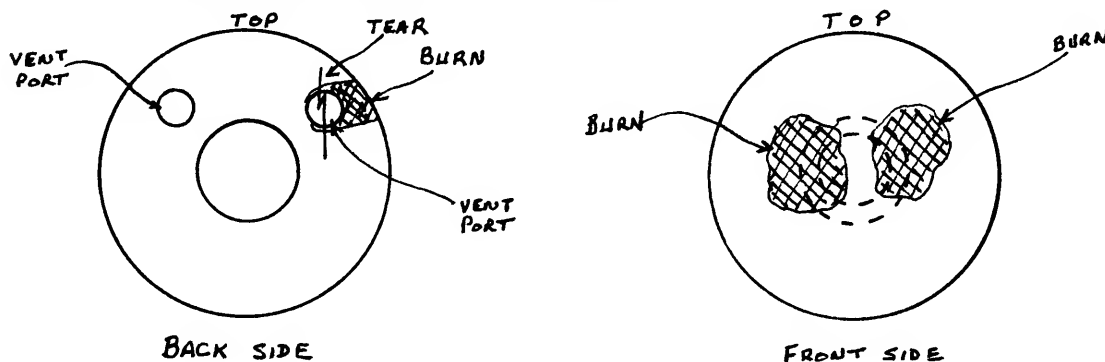
resulted that burned two holes in the face of the airbag fabric opposite the two vent ports on the back side of the airbag.

The fire allegedly resulted in burns to the driver's left face, left eye, left arm, left hand, neck and chest. There was also extensive scorching of the vehicle's left instrument panel, windshield/windshield header, left side of the steering wheel rim, left front door window sill upward and slight scorching the right side of the left front seat back rest.

The airbag burn patterns are as follows:

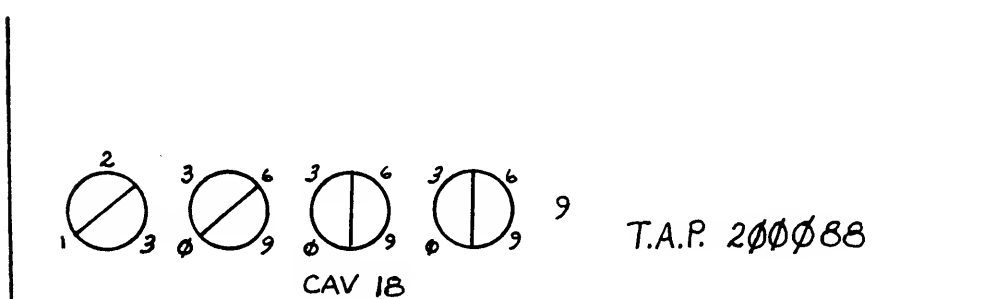
In addition to the above, the following codes were stamped on the back side of the bottom flap of the airbag module:

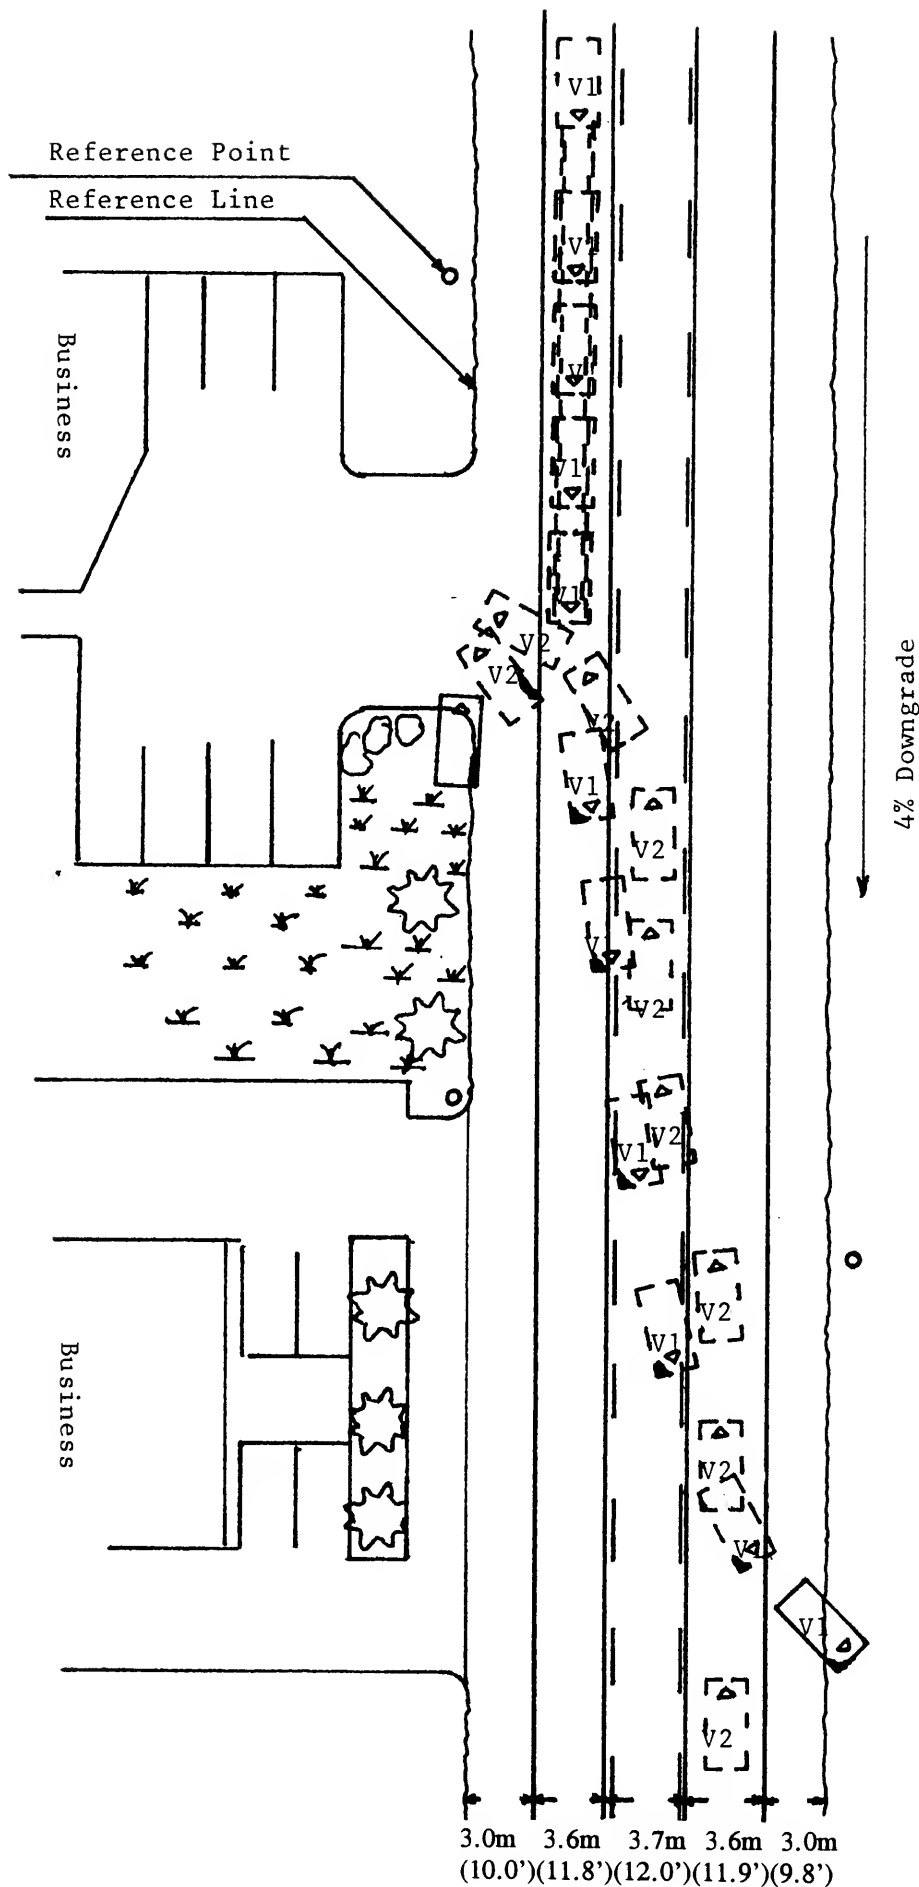
DYNAMIC SCIENCE
DSI-93-AB-013

1cm = 3.6m
1" = 30.0'

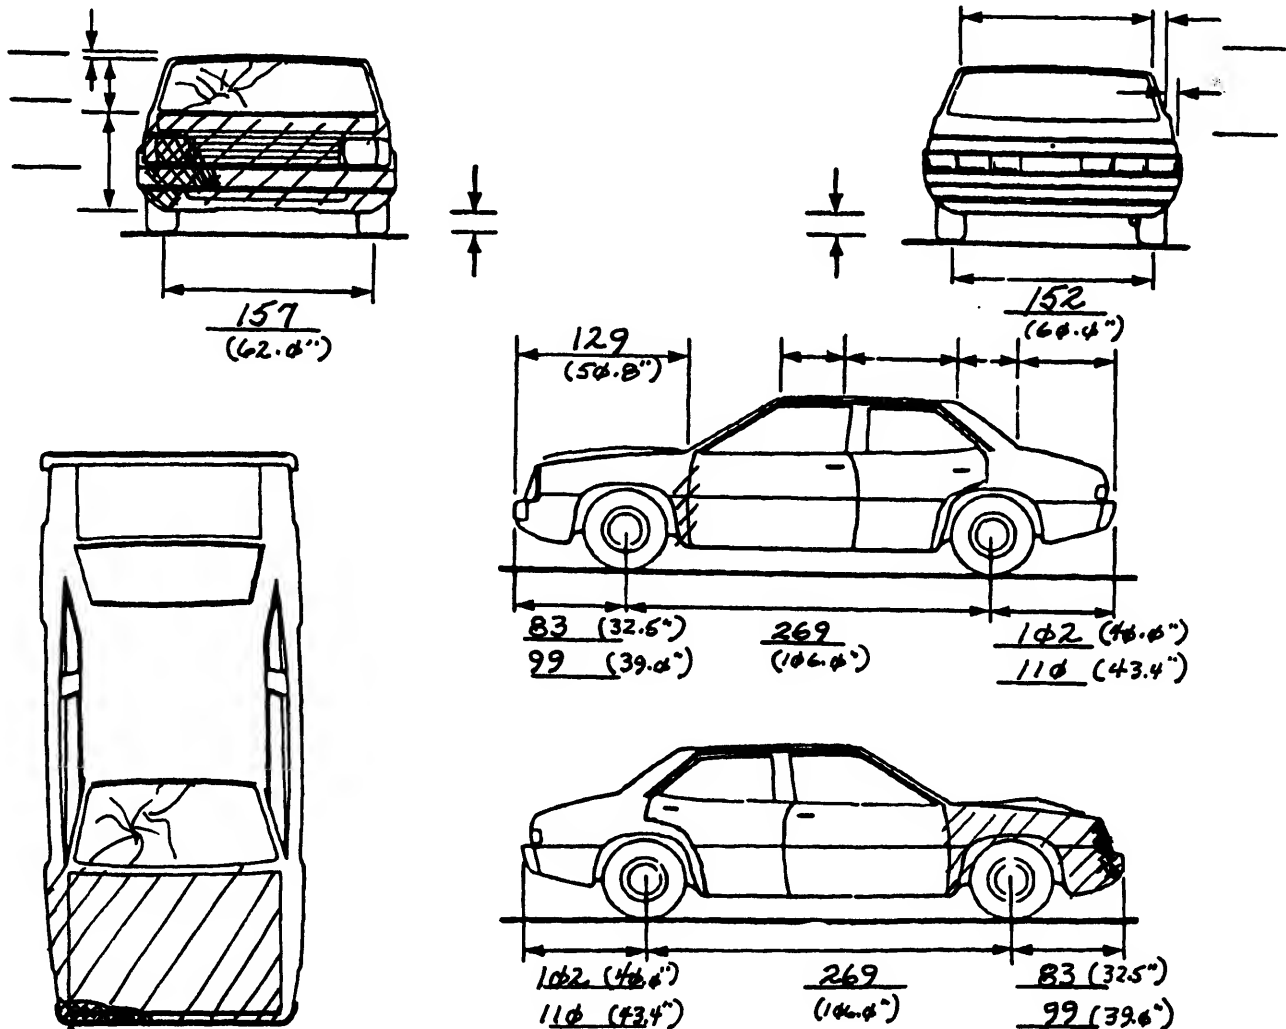
VEHICLE DAMAGE SKETCH

Specific Impact No.	Location of Direct Damage	Location of Field L
01	BEGINS RIGHT FRONT BUMPER CORNER	FULL FRONTAL

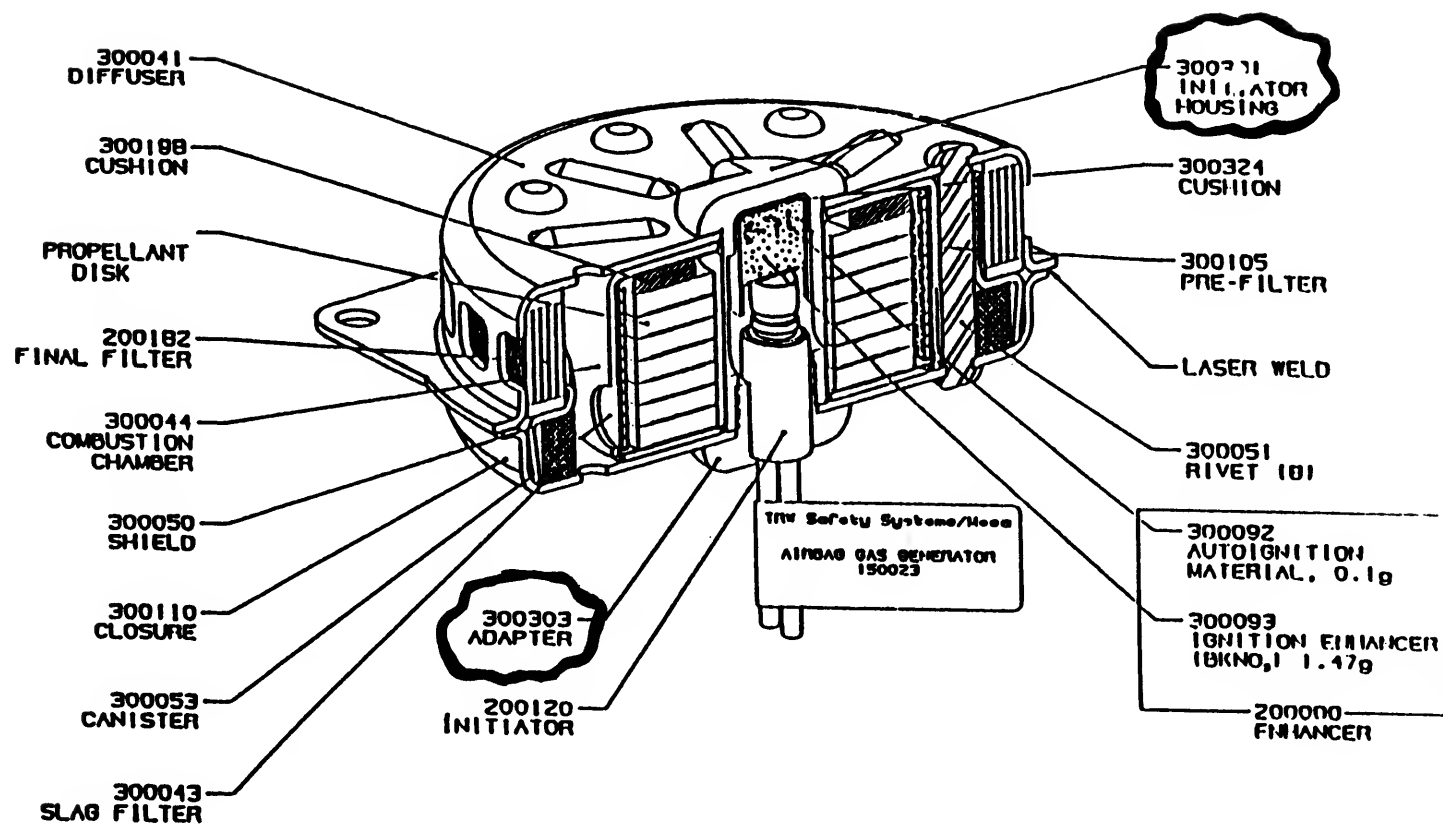
DRAWING B-1

CROSS SECTION VIEW OF INFLATOR

SERIES 90 DRIVER INFLATOR

In [REDACTED] 1990, while conducting a barrier crash test, [REDACTED] noted a separation of a production-level airbag inflator center post housing and adaptor. Subsequent analysis, according to [REDACTED] revealed significant damage to the threads in the housing of the adaptor joint. [REDACTED] states that this damage was consistent with "cross threading" during assembly of the center housing and adaptor. [REDACTED] then, apparently, notified [REDACTED], the manufacturer of the module, on [REDACTED] 1990.

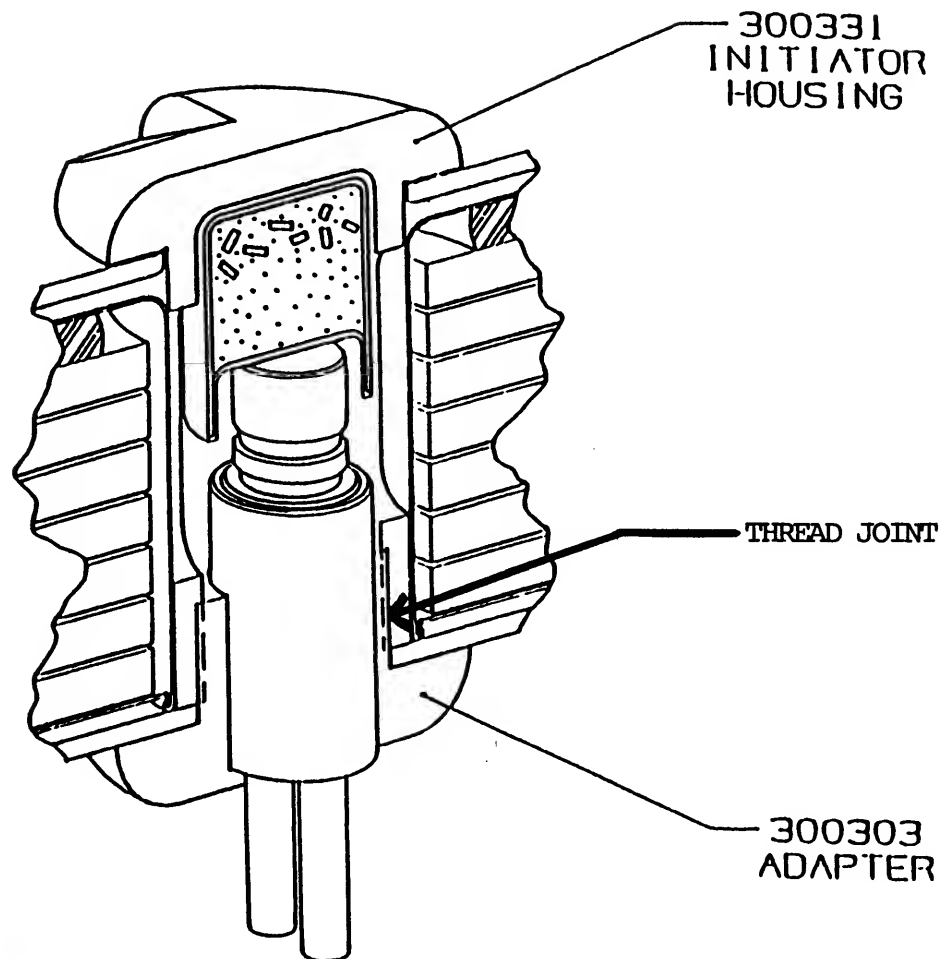
DRAWING B-2

CROSS SECTION VIEW OF ADAPTER AND HOUSING

Also at the time of inspection, the center post and adaptor had been removed from the module and had been examined and tested by an unknown number of examiners. The thread joints and the module itself were in poor condition with heavy corrosion and other deposits masking the threads. The custodians of the module would not permit removal of the corrosion for inspection and photographing.
